Soils and Foundations

Building damage associated with geotechnical problems in the 2011 Tohoku Pacific Earthquake

Kohji Tokimatsu^{a,*}, Shuji Tamura^b, Hiroko Suzuki^a, Kota Katsumata^a

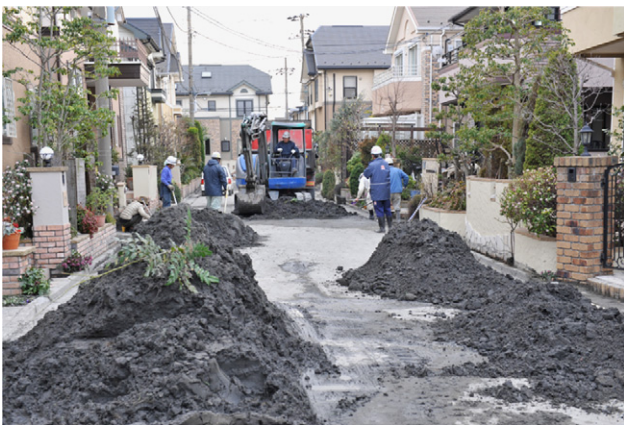
- In many areas where no liquefaction occurred, including Tokyo Disneyland, ground improvement work of some kind had been carried out. This confirms the effectiveness of ground improvement work against earthquake shaking with a peak ground acceleration of 2.0 m/s^2 caused by the magnitude-9.0 earthquake.
- In areas where liquefaction did occur, many sand boils (Photo 1), ground settlements as well as the settlements

Photo 1. Boiled sand stacked on road.

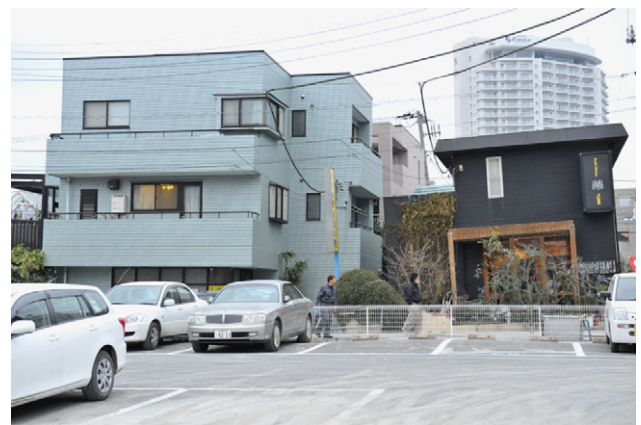
Photo 3. Largely tilted building.

and tilting of buildings and houses on spread foundations (Photos 2–4) were observed, and gaps were created between pile-supported structures and the surrounding ground (Photos 4 and 5), causing damage to piping and other facilities. Underground facilities, such as manholes, emergency water tanks and parking lots were uplifted (Photos 6 and 7), tap water and sewerage systems were

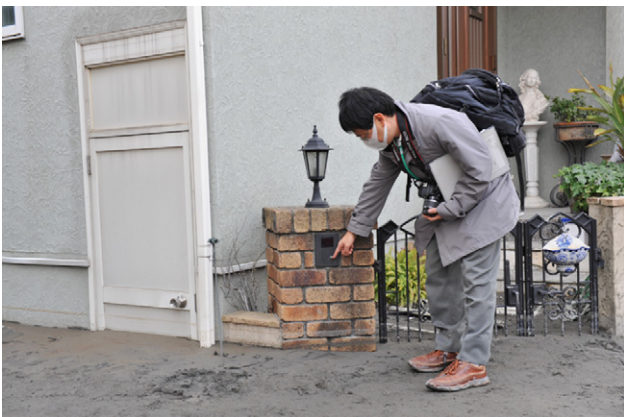
Photo 2. Large settlement of building.

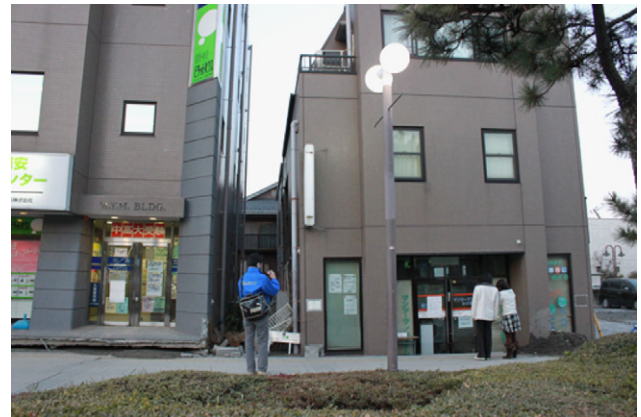
Photo 4. Pile-supported building and settled building.

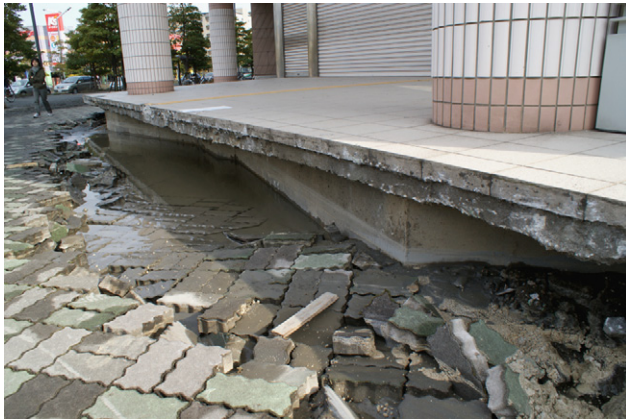
Photo 5. Ground settlement around pile-supported building.

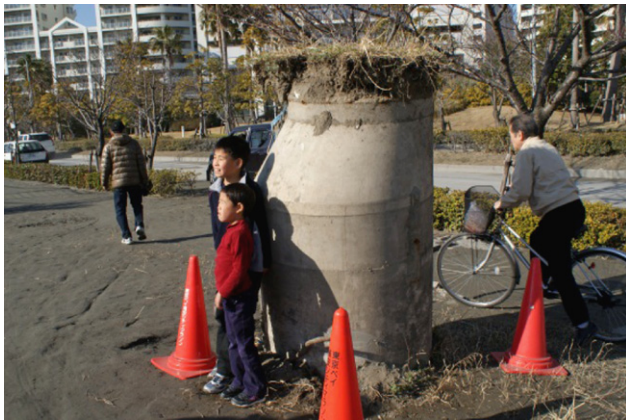
Photo 6. Uplift of manhole.

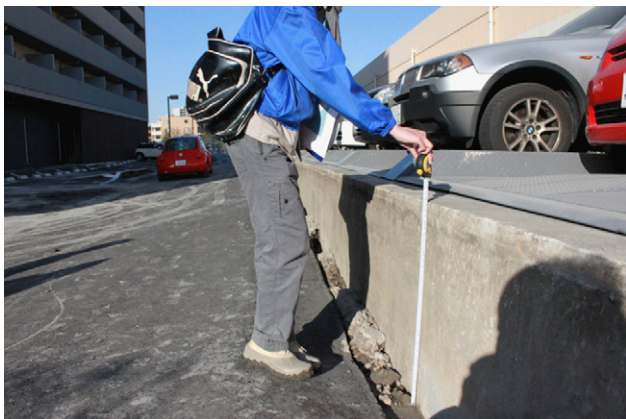
Photo 7. Uplift of underground parking lot.

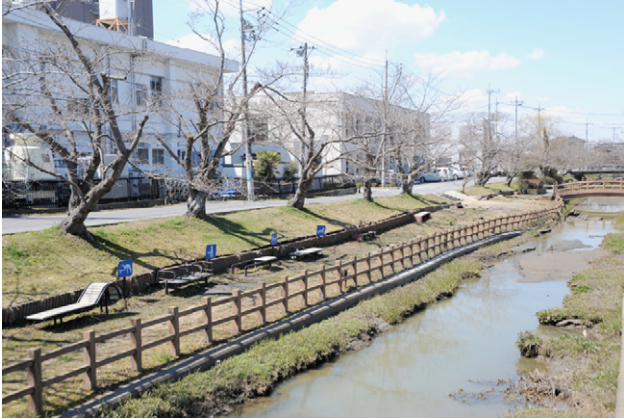
- Due to liquefaction-induced lateral spreading, the stream became narrow and the riverbed lifted (Photo 8). The ground behind the embankment also settled greatly

Photo 8. Lateral ground spreading towards river.

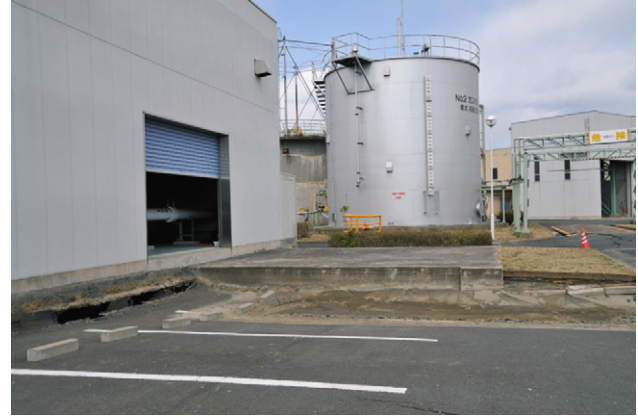
Photo 10. Ground settlement around building.

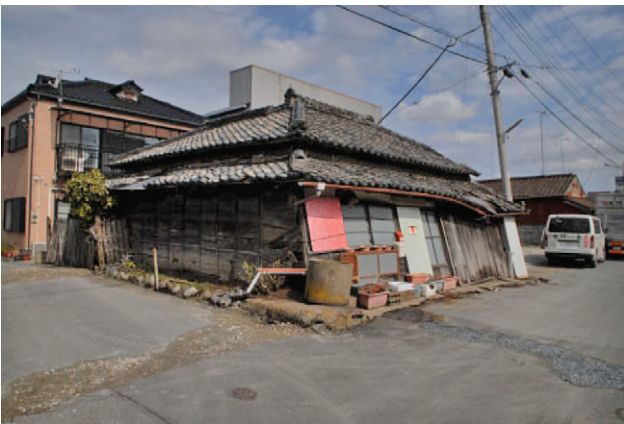
Photo 9. House damaged by lateral spreading.

- Houses and other structures near the embankment had their foundations tilted, as if pushed toward the stream, and some collapsed (Photo 9). Those, which collapsed, were generally old structures that lacked foundation rigidity. A gap of up to 50 cm emerged between the pile-supported buildings and the ground surrounding them.

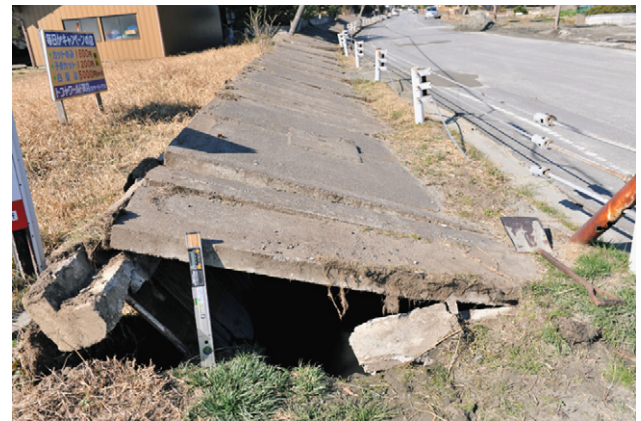
Photo 11. Damage to sidewalk.

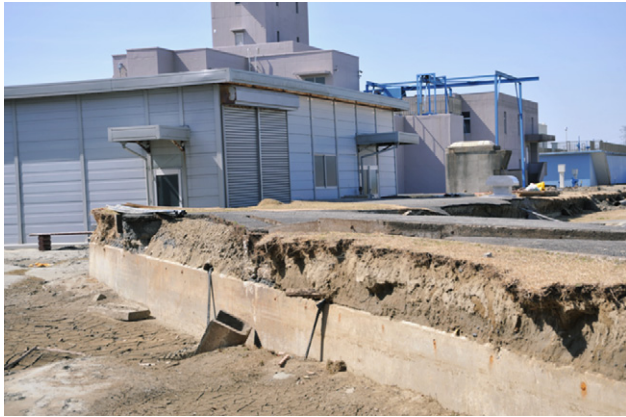
At the Wanigawa Purification Plant, liquefaction-induced ground settlement of up to about 50 cm and the uplift of a public utility duct by up to 50 cm (Photo 12) occurred. This resulted in a gap of up to 40 cm in the vertical direction between a pile-supported building and the duct, which severed some of the wiring inside the duct. Horizontal gaps of up to 15 cm were also created at many joints of the duct,

Photo 12. Uplift of buried conduit.

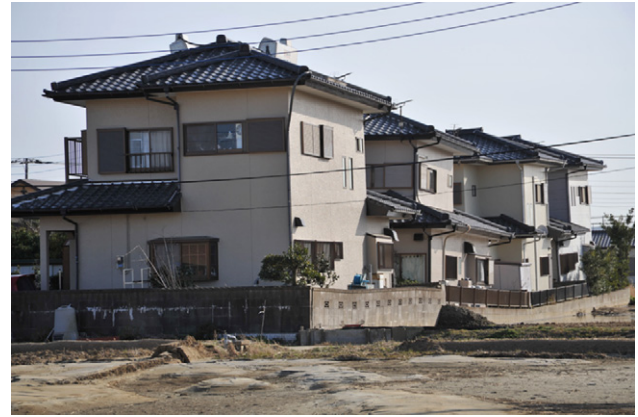
Photo 14. Larger settlement occurring in middle.

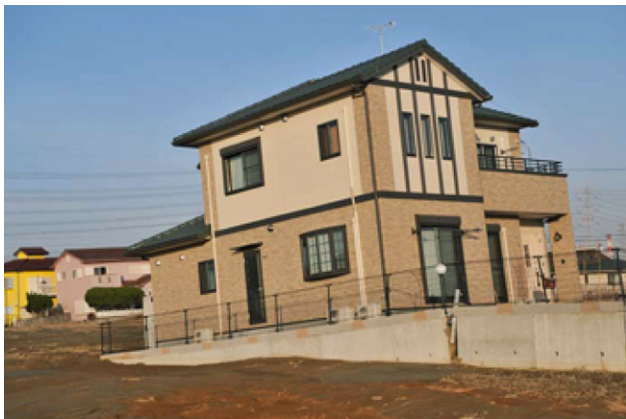
Photo 13. Titled building on edge of fill.

In the Fukashiba and Horiwari areas, liquefaction also caused the settlement and the tilting of buildings on spread foundations (Photo 13), the settlement of the ground adjacent to buildings supported by pile foundations, the uplift of buried structures and bumps and dents in roads and sidewalks. Sand boils in Fukashiba measured up to 50 cm in thickness in some places. The outdoor units of air conditioners were buried in sand boils. When several structures stood closely together, they tended to tilt toward each other (toward the center), probably due to structure-soil-structure interaction (Photo 14). Several houses located at the end of the filled land tilted in the direction of lower ground (outside the land) as the earthfill collapsed due to liquefaction (Photo 13). The northern part of the Horiwari area suffered serious damage—an underground drain was uplifted and houses standing along a street settled by up to 50 cm vis-à-vis the road surface or adjacent houses, but the southern part suffered only minor damage. Puddles of water

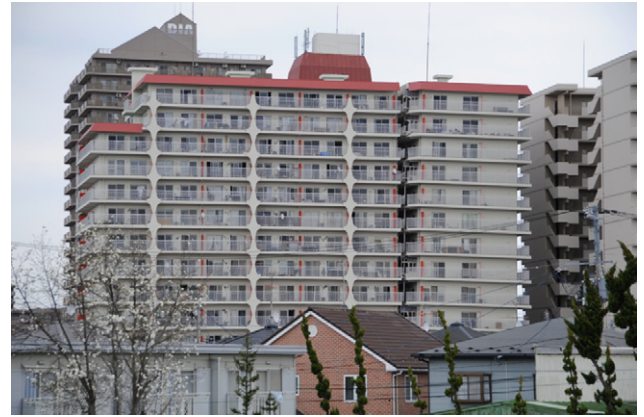
Photo 15. Tilted building.

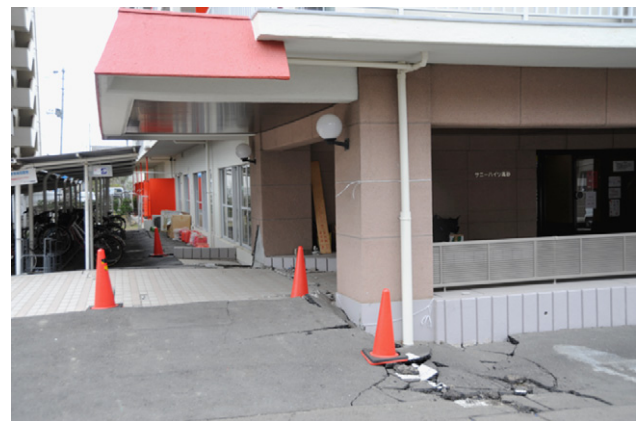
Photo 16. Settlement of pile-supported building.

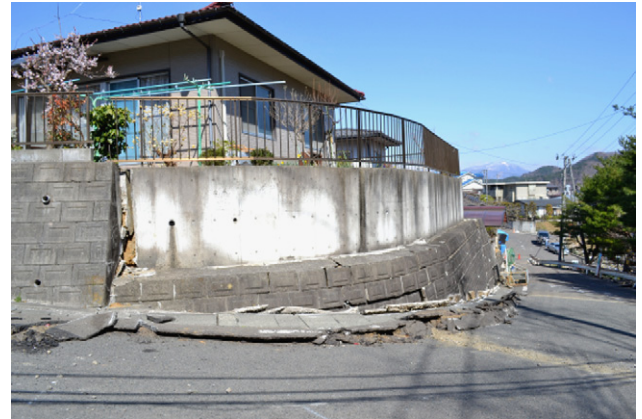
Photo 18. Ground heaving beneath retaining wall.

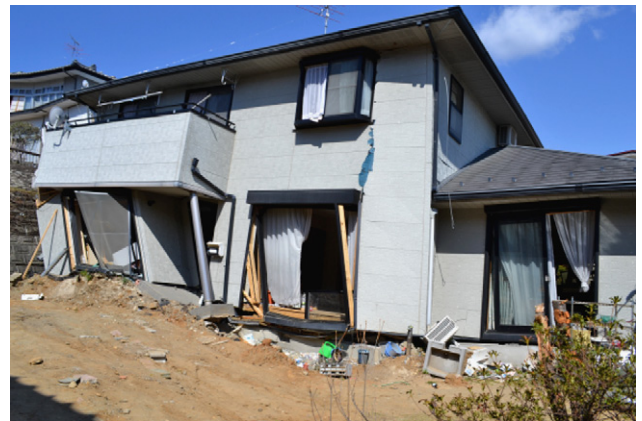
Photo 19. Damage to wooden house.

A house that straddles the landslide area and a cut slope were broken around the boundary (P5). Severe damage to houses was concentrated at the foot of the landslide area, represented by the shaded section in Fig. 22 (Photo 19). The ground in the area spread from the mountain side (left) to the valley side (right), causing the damage to houses. The damaged strip footing

foundation had no reinforcing steel. Damage was greater at the end of the landslide block because ground deformation became greater in both horizontal and vertical directions.

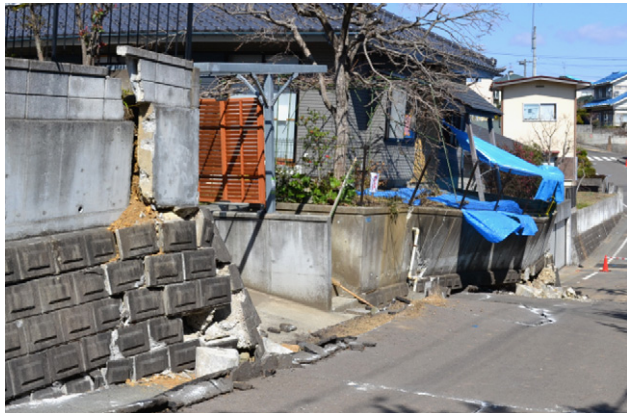
Photo 17. Damage to retaining wall.

Fig. 22 shows a damaged area in Oritate 5-chome, where many retaining walls failed. At the lower part of a slope (P1 in Fig. 22), retaining walls collapsed as if they had been pushed out by backfill soil (Photo 17). Above that point, at P2, the ground under a retaining wall was raised, as Photo 18 shows. It is believed that the earth fill had moved toward the street, exerting a compressive force.

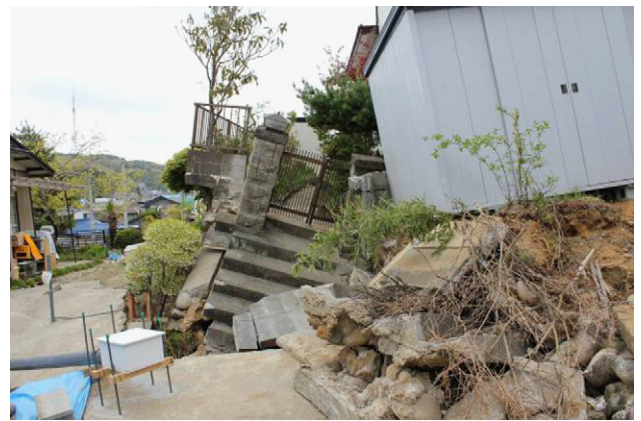
Photo 21. Failure of reclaimed fill.

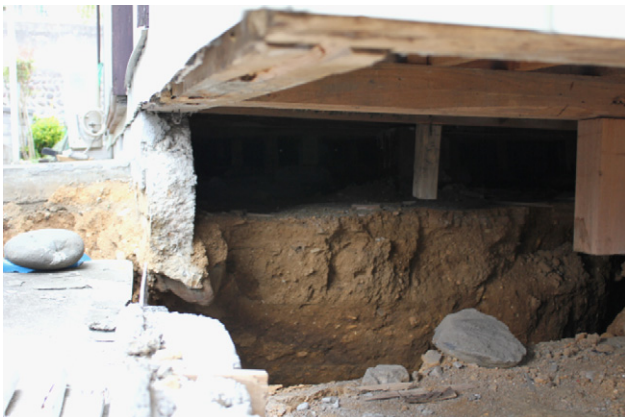
Photo 20. Damage to foundation of wooden house.

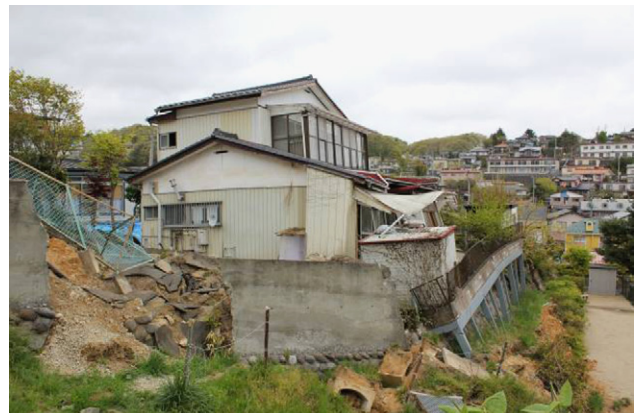
Some buildings at the lower part of the landslide block suffered severe damage as a whole, as seen in Photo 22 (P4 in Fig. 23). In Aoyama 2-chome, the ground shift was large in scale in the upper part of the landslide block, severely damaging many detached houses there. Some of the collapsed houses had been retrofitted and their superstructures had been reinforced against earthquakes. This fact suggests the need to make a comprehensive judgment on anti-seismic reinforcements, considering not just superstructures, but also foundations and land plots.

Photo 22. Damage to wooden house.

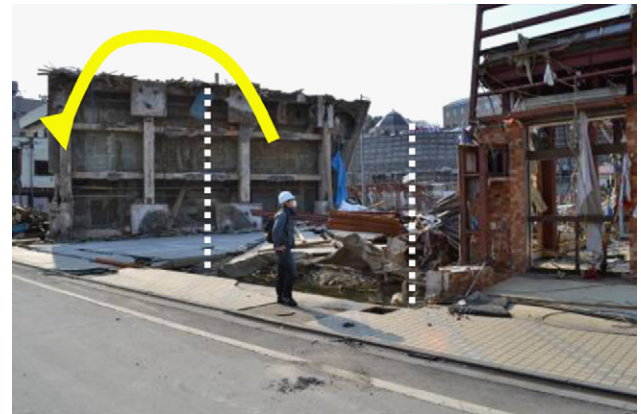
Photo 25. Toppled Building A.

At Point A, a four-story, steel-frame building, supported by a pile foundation, was swept toward the mountain side by about 10 m and toppled sideways (Photo 25). A parking lot between the building's original location and where it ended up had insignificant damage, except for a crack likely made when the building was washed away. This shows that the building apparently floated by the tsunami's force, was carried away and then toppled. The foundation of the building had pile caps, each supported by two or three piles (Photo 26). The toppled building had one pre-stressed concrete (PC) pile with a diameter of 300 mm hanging from its foundation. All the other piles had broken away at their connections with the pile caps. The joints were made of filling concrete, which was weak. Most of

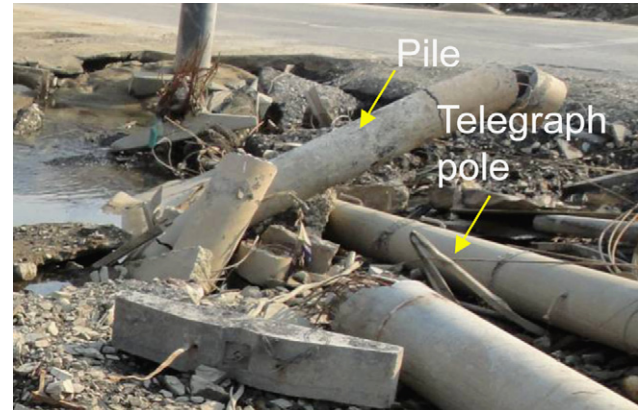
Photo 28. Piles failed by bending and pull-out forces.

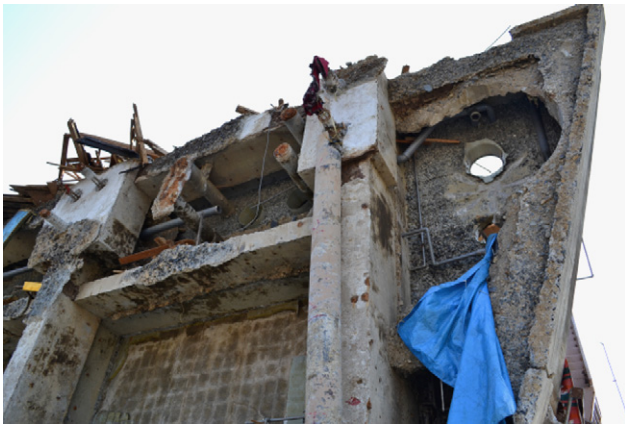
the concrete crumbled and was washed away, with reinforcing steel alone remaining. The pile head joints were possibly damaged by the earthquake and then fractured by the ensuing tsunami.

Photo 26. Pile of toppled Building A.

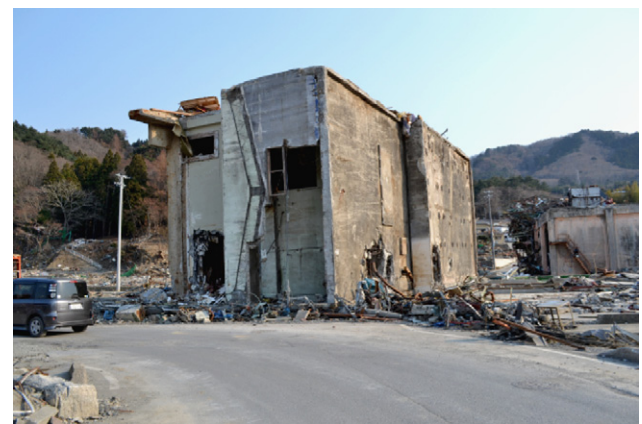
Photo 29. Overturned Building C.

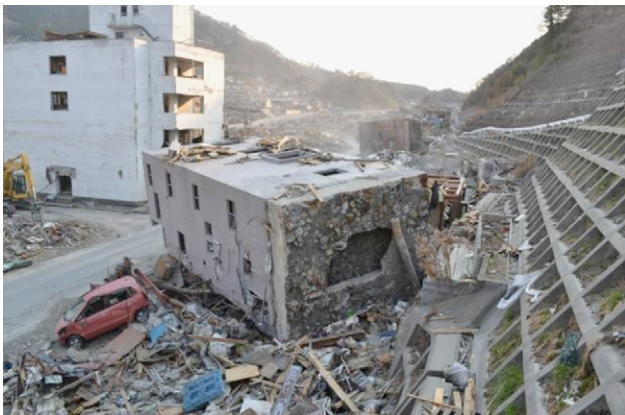
Photo 27. RC Building B carried 70 m away and toppled.

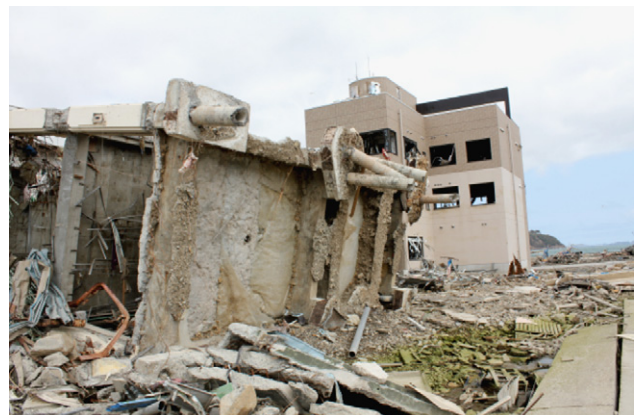
Photo 30. Toppled Building D.

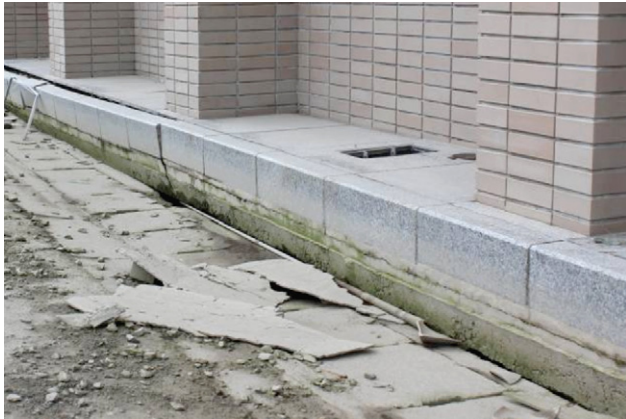
Photo 31. Ground settlement around nearby building.

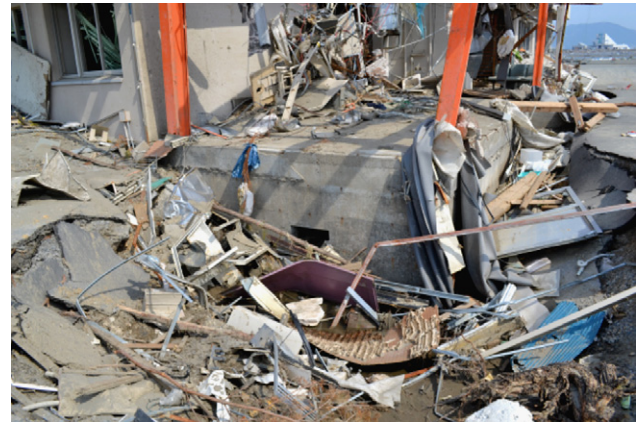
Photo 34. Scour around Building A.

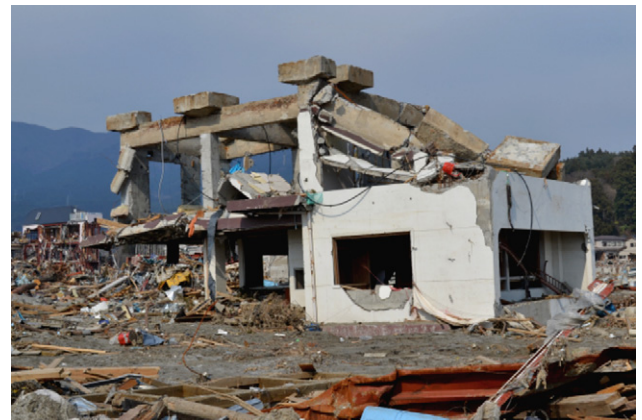
Photo 35. Overturned Building B.

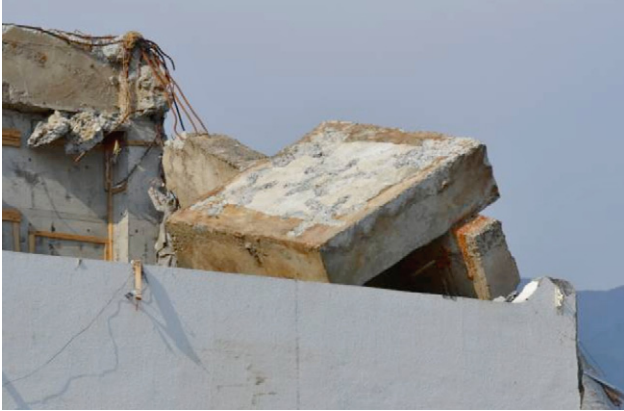
Photo 36. Pile cap of Building B.
